Kewaunee Nuclear Power Plant
N490, State Highway 42
Kewaunee, WI 54216-9511
920-388-2560

Docket 50-305
Operating License DPR-43
Kewaunee Nuclear Power Plant
Reportable Occurrence 2002-002-00

LICENSEE EVENT REPORT (LER)

Technical Specifications Required Shutdown: CCW System Leak Could Not Be Repaired Within LCO

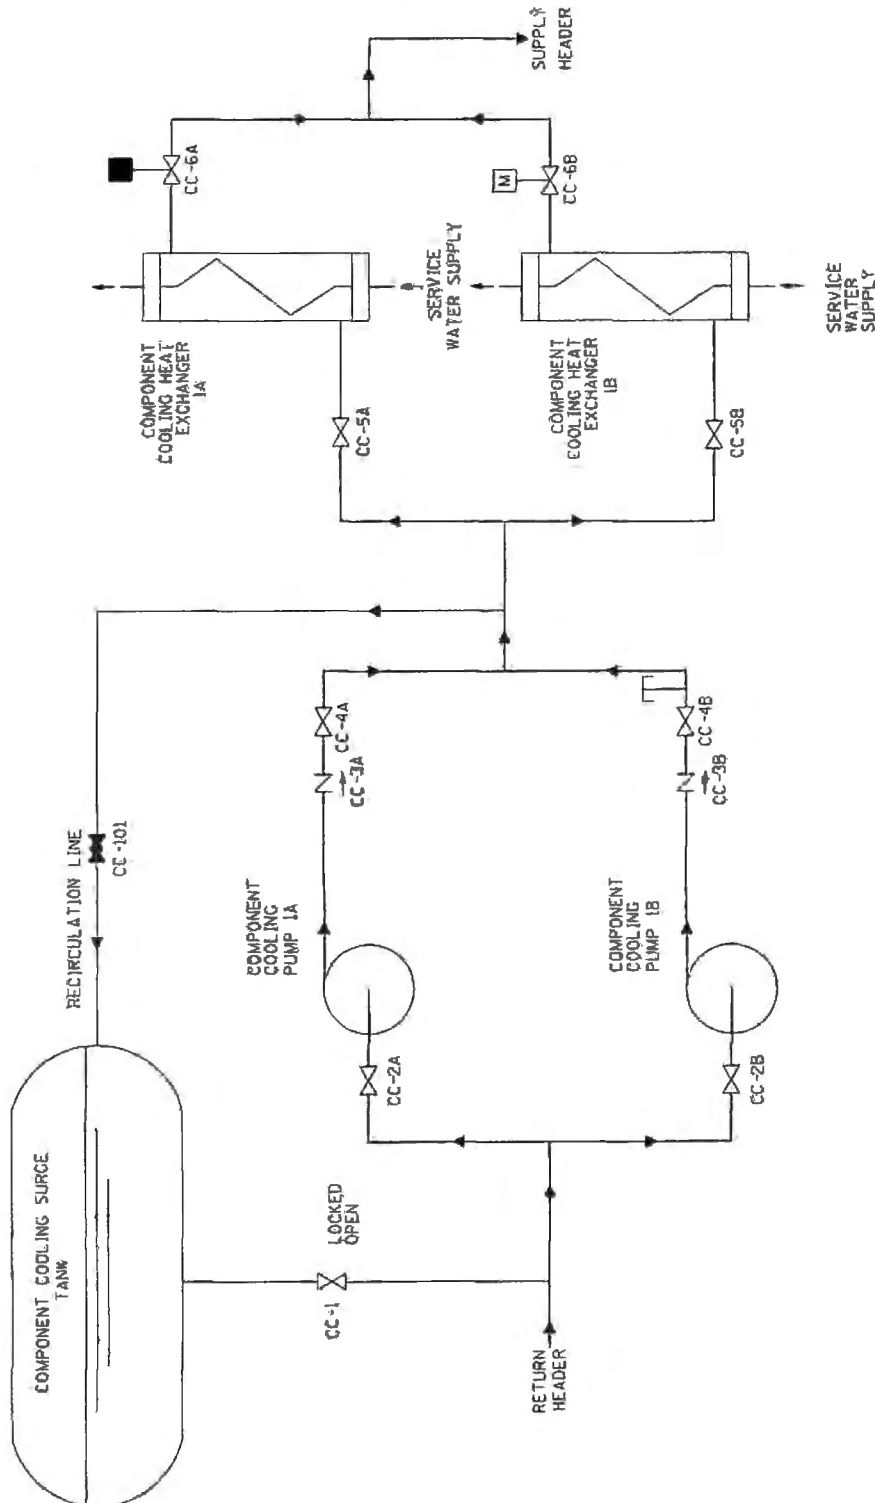
Figure 1: Simplified CCW Sketch

As stated in the Kewaunee Updated Safety Analysis Report (USAR) Section 9.3, the CCW system consists of two CCW pumps, two CCW heat exchangers, a CCW surge tank [TK], cooling lines to various components to be cooled, and associated piping, valves, and instrumentation (see Figure 1). CCW piping to various components is arranged in parallel flow circuits. During normal operation, the CCW pumps and heat exchangers are operated as needed to accommodate the heat removal loads. One pump and one heat exchanger can provide 100% heat removal capability during normal operation. Two pumps and two heat exchangers are used to remove the residual and sensible heat during plant shutdown. If one of the pumps or one of the heat exchangers is not operable, safe shutdown of the plant is not affected; however, the time for cooldown is extended.
